Research was conducted at San Diego State University's (SDSU) Soil Erosion Research Laboratory to evaluate the performance of SiltSoxx™, silt fence, and straw wattles under various installation scenarios. Sediment control barriers were installed at the base of the slope and exposed to experimental conditions using a modified ASTM 6459 standard test method typically used for erosion control blankets. The sediment control barriers

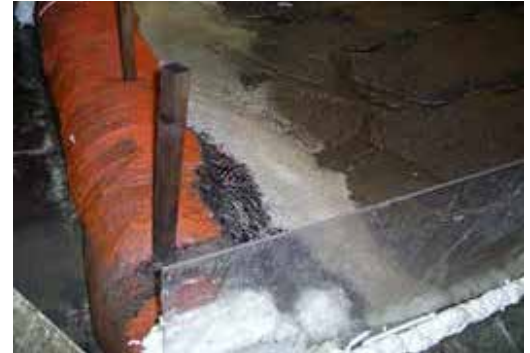
were installed on a loamy sand soil at the base of a 3:1 slope with an exposed soil and drainage of area of 2 meters wide by 8 meters long. The design storm utilized for this research project used a Norton Ladder Rainfall Simulator developed by the USDA ARS National Soil Erosion Research Laboratory and was programmed for an intensity and duration of 2 in (5 cm)/20 minutes followed by 4 in (10 cm)/30 minutes. Average peak runoff rate exposed to the sediment control barriers was 28.4 liters/min, average runoff volume was 986 liters, average sediment concentration was 460,000 mg/L, and average sediment load was 385 kg. Experimental runs were conducted in triplicate to obtain statistical means.

The sediment control barriers were installed correctly, according to specification, and incorrectly, subjectively determined to represent typical field installation. SiltSoxx™ were installed according to Filtrex® standard specifications (including prepared surface, staking, and backfill) and were also installed on the soil surface without surface preparation, staking, and backfill (incorrect installation). Silt fence was installed correctly, according to staking, trenching, and backfill compaction specifications; and incorrectly, using staking, minimal trenching, and backfilling. Straw wattles were installed correctly, according to staking and trenching specifications; and incorrectly, with staking and without trenching.
