## OCTORARO CREEK STABILIZATION NOTTINGHAM, PA

**Application:** Bank Stabilization  
**Product:** C700BN

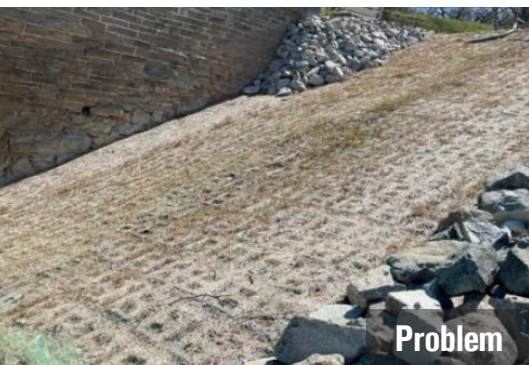
Problem

**Problem:** The Octoraro Creek facility in Nottingham, PA near the Conowingo dam and Susquehanna River, included an eel lift, designed to collect and transport eels along the waterway bypassing the impassable dam structure. The eel lift was originally installed on a steep dam embankment that was armored with poor performing, environmentally non-friendly hard concrete block structure. As a measure to increase the site's erosion control and improve the environmental habitat at the site, the Octoraro Creek facility turned to Western Green for a natural option to add stability and vegetation to the steep slope.

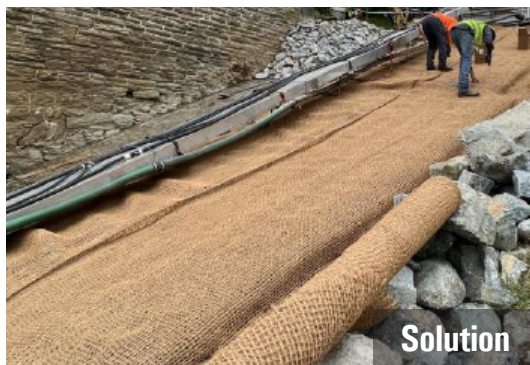
Solution

**Solution:** As a solution, the concrete blocks were soil filled, and seeded and the C700BN erosion control blanket was selected and installed over the seeded bed and secured into place. The C700BN is a long-term, yet temporary erosion control blanket that combines the strength of heavy coir nets with a fiber matrix to provide the strength, yet ability to naturally vegetate the steep embankment. The C700BN offered a flexible erosion control blanket that provides intimate contact to the soil grade reducing the affects of storm water runoff. Because C700BN is all-natural, it is an excellent choice for waterway projects.

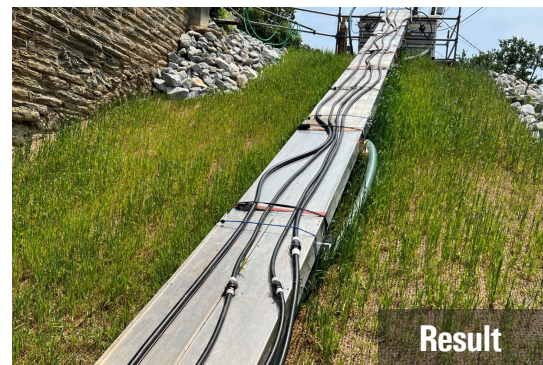
Result

**Result:** After the installation of the erosion control blanket, the steep embankment began its initial vegetation phase. The grasses soon filled in and provided surface stabilization of the soils. Now after the site has fully established, the Octoraro Creek facility benefits from the natural and aesthetically pleasing stabilized slope.

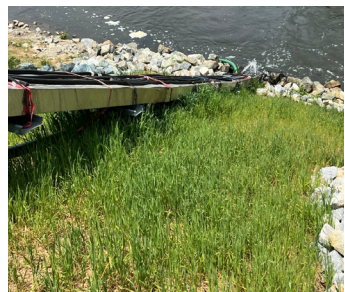
- The C700BN consists of a heavy 700 g coir net, a coconut fiber matrix, and jute bottom net providing an 100% biodegradable erosion control blanket
- Provides extended-term erosion protection for a minimum of 36 months, allowing ample time for site establishment.
- C700BN provides significant resistance to hydraulic forced and provides increasing levels of performance as vegetation establishes.
